IHAA Symposium 2006
Baltimore, Maryland

Challenges in Anodic Oxide Finishing Arising
From Different Substrate Manufacturing Processes

*By: Dr. Jude Mary Runge
CompCote International, Inc., Elmhurst, Illinois, USA*

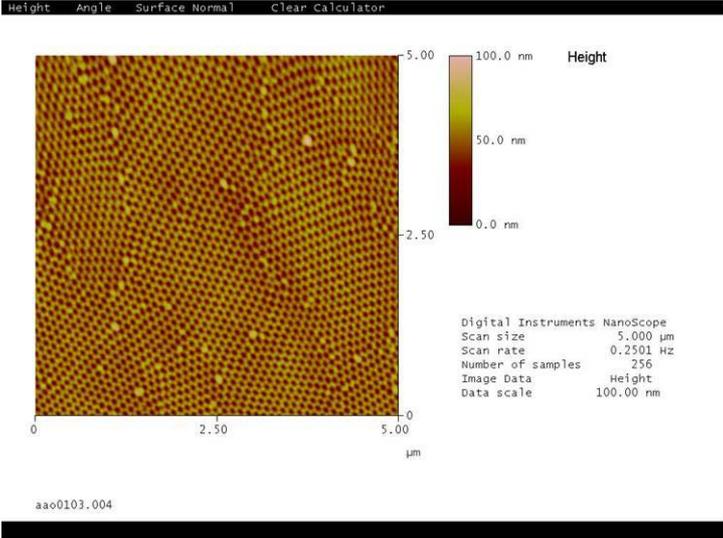
Figure No. 1: AFM image of the top of an anodic oxide finish shows several columns per substrate grain arranged in a hexagonal close-packed nanoscale structural order.

In general, for all samples anodized, the column sizes and spacing varied, depending upon the current density and electrolyte utilized. They ranged in size for pore to pore distance from 51 nanometers for lower current density finishes to 100 nanometers for higher current density finishes. See figure nos. 1 and 2.

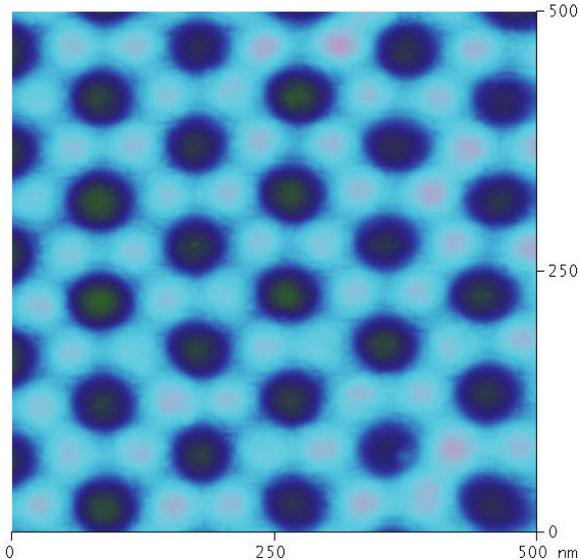
Figure no. 2: AFM image of the aluminum substrate after the anodic oxide was chemically removed shows the arrangement of the oxide on the substrate. Each pore center is represented by a dark spot. The column walls are represented by the hexagonal arrangement of the light blue spots. The pink spots are centers of impingement between column walls.

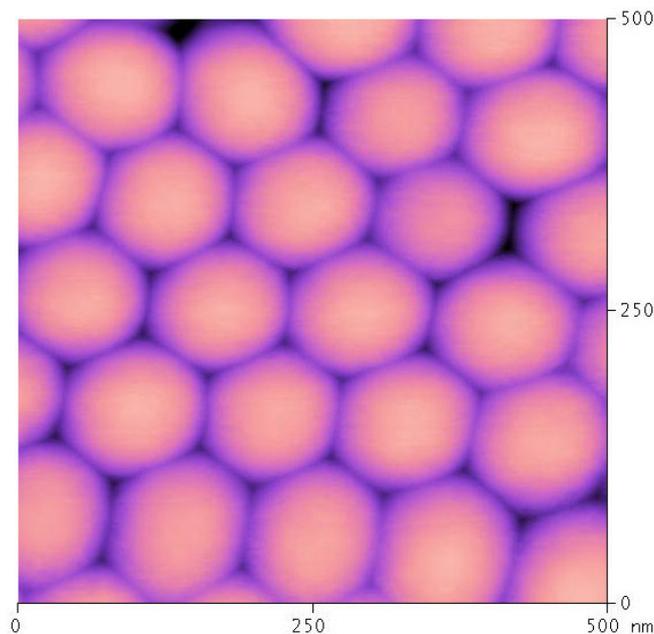
Figure No. 3: AFM image of the underside of the anodic oxide finish after removal from the aluminum substrate. Note the simple hexagonal arrangement of each rounded column bottom. Also note the variations in the interstitial spacing. Each column measures approximately 100 nm from edge to edge.

Images of the underside of the porous oxide finish show conclusively that each column base is rounded at the bottom and that the interstitial spaces are regular but can vary. This result indicates structural order of the anodic finish can be disrupted at the finish – substrate interface due to substrate defects that intersect the surface. The image shows that disruption of the structure occurs between columns of the anodic oxide and clearly documents the importance the substrate quality has on the finish quality. In addition these images clearly show no evidence of a continuous underlying barrier layer, but show each column is part of a nanoscale finish network. See figure no. 3.

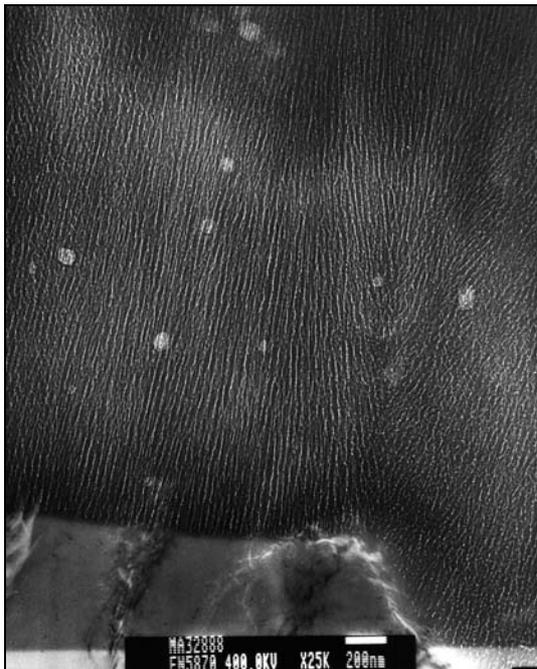
Figure No. 4: Representative TEM micrograph of a Type II anodic oxide finish.

Images of the Type II and Type III anodized finishes disclosed they were comprised of several close-packed unidirectional columns with closed, rounded bottoms. The number of columns, pore diameter and column wall thickness was consistent for each finish type but varied with process type. The Type II finish was comprised of many fine columns, each with a uniformly small pore diameter. The pore diameter

measured approximately 5 - 10 nanometers and the column walls approximately 10 - 15 nanometers thick. (Approximately 25 nanometer pore center to pore center distances.) See figure no. 4.

However, in industry we rarely encounter an ideal substrate. Nucleation sites will exhibit preferences for the more ideal such as certain crystallographic surface orientations, and other atomic level defects may impede nucleation, such as vacancies, dislocations, steps or ledges. Grain boundaries which can function as sinks for atomic level defects can also impede nucleation. Alloy additions which may be inert to the anodization process can retard oxidation kinetics uniformly, as when copper dissolves into the electrolyte while the aluminum oxidizes, or nonuniformly, as when inert inclusions such as silicides or insoluble alloy additions, such as lead, segregate and intersect the substrate surface. Our TEM analysis results clearly document such substrate – finish interactions, see figure nos. 4 and 5.

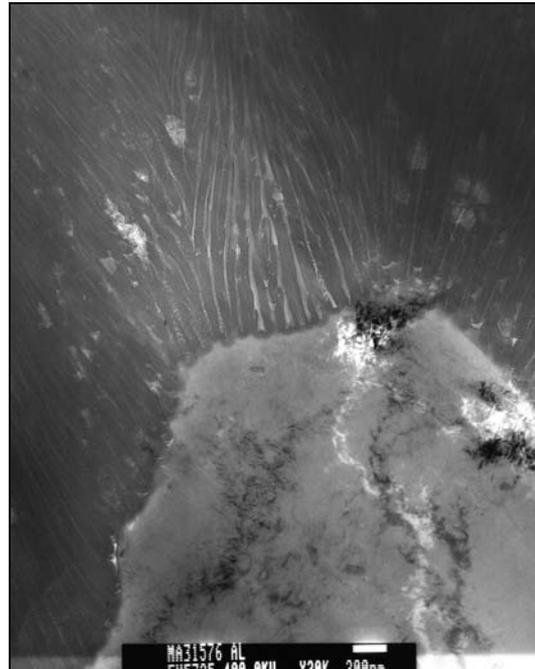
Figure No. 5: Representative TEM micrograph of a Type III anodic oxide finish.

The Type III finish exhibited fewer columns with wider pore diameters and thicker column walls. The pore diameter measured approximately 30 nanometers and the column walls approximately 25 nanometers thick. (Approximately 80 nanometer pore to pore distances.) A feature more easily discernible on the Type III finish was that of a distinct boundary line between each column. The boundary lines exhibited the same unidirectional character as the central pore and appeared to “knit” the individual columns together. These features were also well documented in the AFM images and came to be called “knit lines” in our research. See figure no. 5.

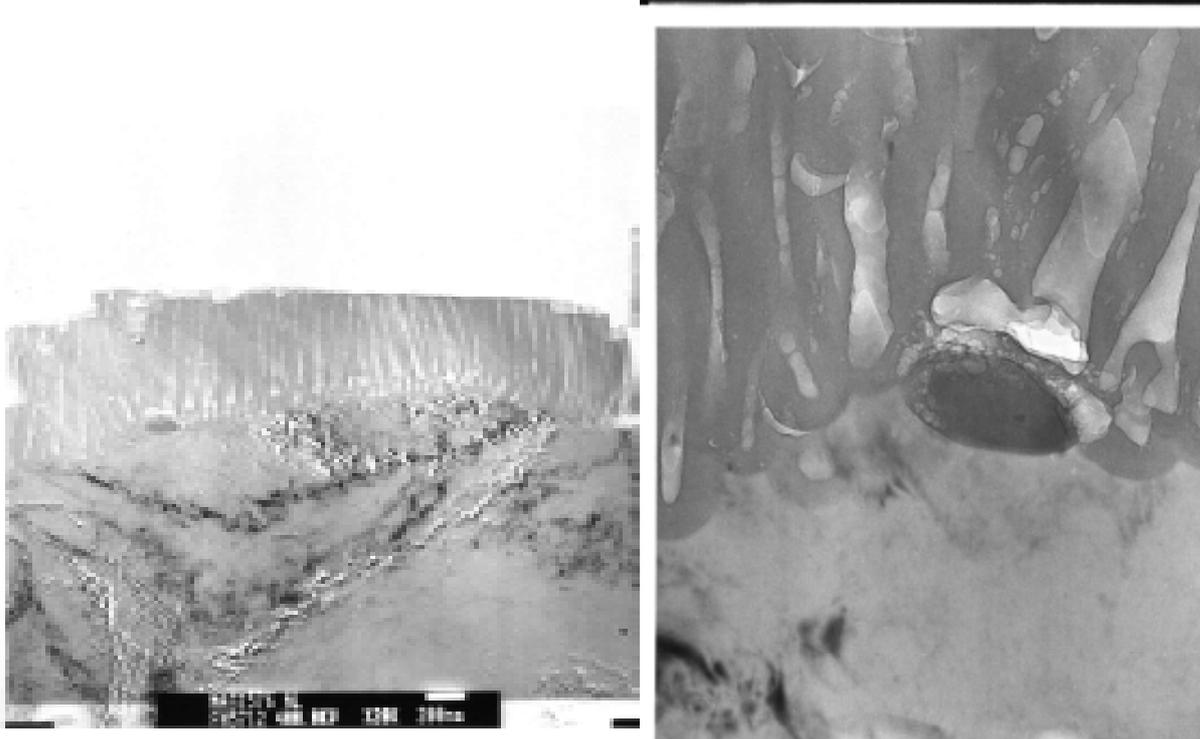
Figure 6a: X15,000 Documentary TEM micrograph of a Type III anodized aluminum substrate. Note the presence of circular inclusions (iron-chromium) which were taken up into the Type III columnar structure during anodization. Atomic level defects such as grain boundaries and dislocations in the aluminum substrate also affect the finish structure at the finish-substrate interface. Figure 6b: X100,000 Higher magnification TEM micrograph of the iron-chrome inclusion at the substrate – finish interface. Outgassing at inert inclusions can cause blistering in the finish.

TEM also disclosed that while the anodized finish exhibited an ordered appearance, interfacial disorder was observed at the substrate in areas where the anodic oxide intersected grain boundaries, dislocations and inclusions. Disorder was identified as the apparent increase in column bases in the interfacial defect areas, increased outgassing (entrapped gas bubbles within the finish) and deviation from the perpendicular orientation of the finish to the substrate. Recovery of the finish growth was noted as additional growth fronts were observed below the disordered areas. See figure nos. 6a and 6b.

Through examination and analysis of more complex wrought alloys with the TEM, it became clear that in segregated alloy solutions with inert inclusions, corrosion (anodization of the aluminum substrate) will proceed about and even around the inclusions, lifting them into the anodic oxide finish as it grows out from the substrate. The impact of inert or insoluble defects such as inclusions, grain boundaries and atomic level sinks on the finish is in the spacing of the oxide nuclei during surface reconstruction. This disruption in order can lead to irregular growth and irregular intercolumn spacing. However, as the surface is consumed and a more ordered surface is presented for oxidation, the finish recovers its ordered structure as growth takes place. This is also documented in figure 6.

In segregated alloy solutions with inert inclusions, corrosion will proceed about and even around the inclusions, lifting them into the anodic oxide finish as it grows out from the substrate. The impact of inert or insoluble defects such as inclusions, grain boundaries and atomic level sinks on the finish is in the spacing of the nuclei. This disruption in order can lead to irregular growth and irregular intercolumn spacing. However, as the surface is consumed and a more ordered surface is presented for oxidation, the finish recovers as growth takes place. See figure no. 6.

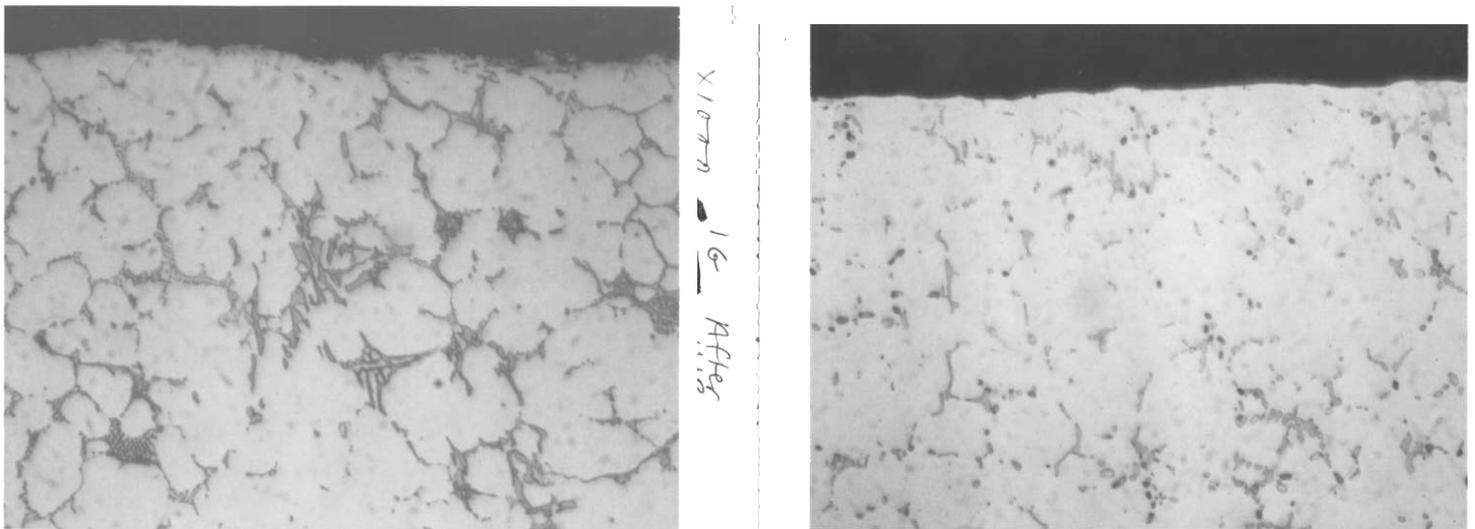
Figure 7a and 7b: X 1000, microstructural detail developed with Keller's reagent. Note the distinct change in microstructure by the reduction in the silicon-rich script portion of the microstructure due to the HIP process. By re-solution treating the ADC 6 alloy, the surface anodized more uniformly.

Small anodized die castings exhibited variations in the thickness of the anodized finish, with some components being unacceptably thin. Metallographic examination disclosed the ADC 6 alloy, a high strength low alloy composition that is typically easier to anodize, displayed a highly segregated microstructure. The script phase, $(\text{Fe,Mn})_3\text{SiAl}_2$, intersected the surface and did not anodize at the same rate as the aluminum rich portions of the substrate. In areas where the script phase was more pronounced, the reduced thickness was also more pronounced.

The substrate microstructure was homogenized through a heat treatment process called Hot Isostatic Pressing or HIP. The HIP process re-solution treated the cast microstructure, providing a more homogeneous surface for anodizing, and as an added plus, consolidated the microstructure to remove porosity throughout the casting. See figures 7a and 7b.

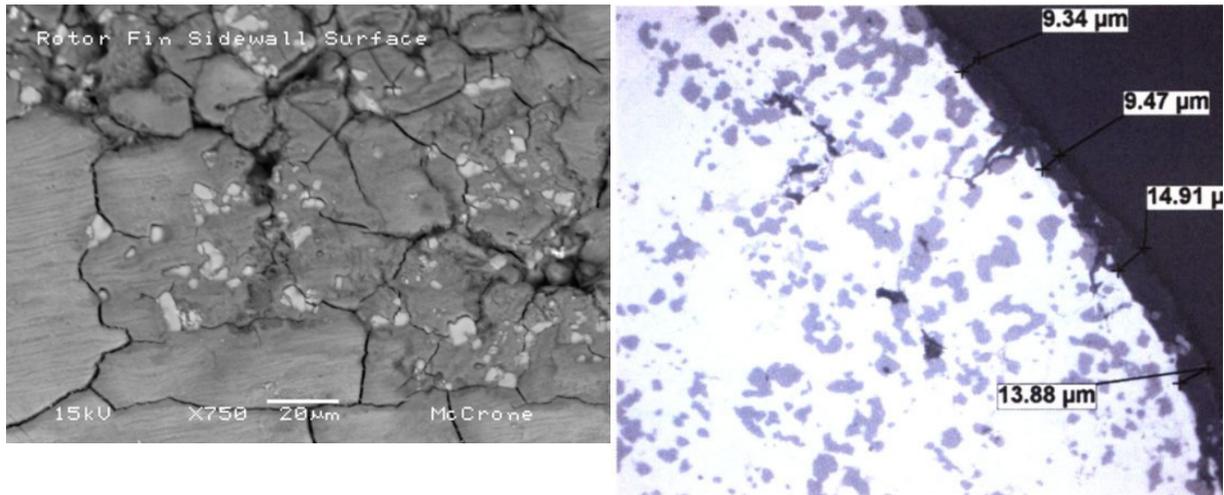
Figure 8a (left): SEM photomicrograph documenting the silicon inclusions within the anodized finish. Note the dark gray discoloration (copper) on the light gray finish surface (anodic aluminum oxide) in the region of each white-appearing inclusion (silicon). Figure 8b (right): Metallurgical cross section of the rotor determined a high level of segregation throughout the sintered component. In one piece, the Si concentration could range from 16% to 27% in different areas. Wherever a silicon-rich area intersected the surface, a reduction in finish thickness and/or crack would result.

Rotors manufactured from sintered aluminum alloy powder exhibited discontinuities and discoloration in the anodized finish. Examination and analysis disclosed the components were highly segregated such that a bulk alloy chemistry that was specified as a maximum 14% Silicon, locally exhibited concentrations as high as 27%. When these areas of high Silicon concentration intersected the surface, not only was the anodic oxide thickness significantly reduced, but dark-appearing discoloration was deposited around the silicon inclusions on the surface of the finish. EDS analysis determined the discoloration was comprised of metallic copper.

SEM and metallographic examination of the rotors enabled documentation of the high level of segregation in the sintered substrates, and lead to a re-evaluation of the sinter process parameters, such as alloy powder mixing prior to molding and the time and temperature of the sinter process. The high level of segregation was clearly not an anodizing problem and could not be related to the finishing process. See figures 8a and 8b.

As documented in the wrought specimens analyzed with the TEM, inert inclusions will not participate in the anodic oxide finish reaction and will be taken up into the finish, creating local discontinuities in the nanoscale finish order. In addition, copper in solution will be dissolved in the anodizing electrolyte, and as a positive counterion, will redeposit on the component surface in areas where the oxidation kinetics are retarded due to the inert, high resistance of the inclusions. Therefore, the copper redeposited on the anodized rotor surface.
